New Hampshire Volunteer Lake Assessment Program

2002 Interim Report for Lake Skatutakee Harrisville

NHDES Water Division Watershed Management Bureau 6 Hazen Drive Concord, NH 03301

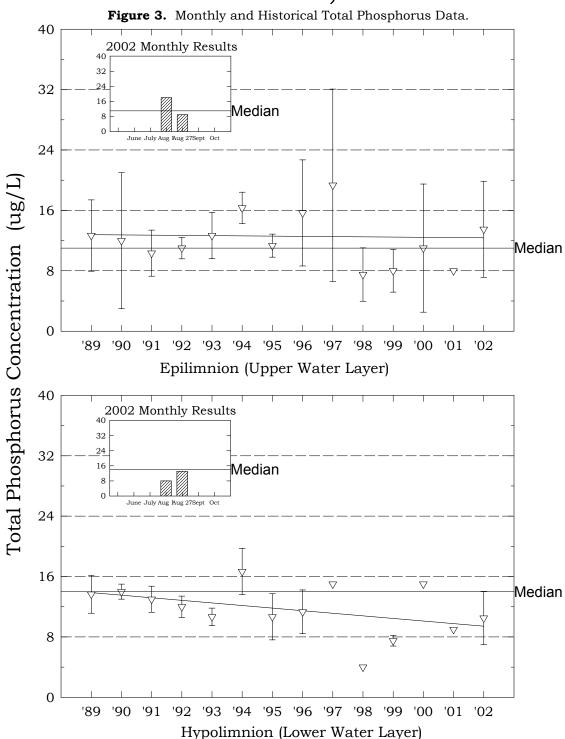
Figure 3 and Table 8: The graphs in Figure 3 (Appendix A) show the amounts of phosphorus in the epilimnion (the upper layer) and the

hypolimnion (the lower layer); the inset graphs show current year data. Table 8 (Appendix B) lists the annual maximum, minimum, and median concentration for each deep spot layer and each tributary since the lake/pond has joined the program.

The historical data for the epilimnion (upper layer) show that the 2002 total phosphorus mean is **slightly greater than** the state median. The historical data for the hypolimnion (lower layer) show that the 2002 total phosphorus mean is **less than** the state median.

Overall, visual inspection of the historical data trend line for the epilimnion and the hypolimnion shows **a variable** total phosphorus trend, which means that the concentration has **fluctuated** since monitoring began.

One of the most important approaches to reducing phosphorus loading to a waterbody is to continually educate watershed residents about its sources and how excessive amounts can adversely impact the ecology and value of lakes and ponds. Phosphorus sources within a lake or pond's watershed typically include septic systems, animal waste, lawn fertilizer, road and construction erosion, and natural wetlands. If you would like to educate watershed residents about how they can help to reduce phosphorus loading into the lake/pond, please contact the VLAP Coordinator.
